Earthquake damage to University of Newcastle Libraries

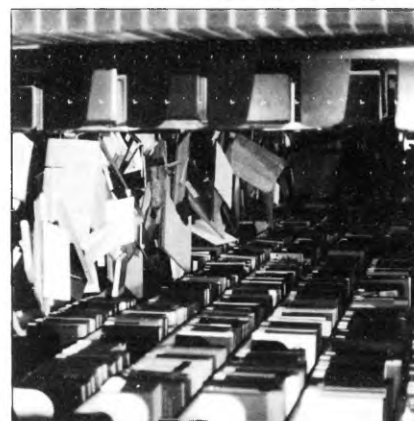
The Earthquake which hit Newcastle on 28 December left much of the Auchmuty Library looking as though a cyclone had passed through it. The floors of four of the six main reading rooms were covered with thousands of books which had fallen from the shelves, together with hundreds of broken ceiling tiles and insulation batts. Other tiles were hanging loose from the ceiling with exposed wiring, and some end wall shelving had sprung loose from bolting and was swaying precariously. Everything was covered with layers of dust. Fortunately the library was closed for the Christmas break and so possible injury to library users and staff was averted.

Most books fell from the top two shelves, and the 'fallout' was worse on the top floors, especially at the extremities of the building. Fortunately only some fifty books were badly damaged. The fact that most of the shelving had been braced undoubtedly saved the library from greater damage, as it prevented the shelves from toppling over in a concertina effect across the Reading Rooms. Even with bracing, a number of the shelves 'walked' up to 5 centimetres.

Thousands of books fall from the shelves: Auchmuty Library
